**Flood Control Project Maintenance
Levee Inspections**

Fall 2015 Levee Maintenance Deficiency Summary Report

Sacramento River Basin

Sutter Maintenance Yard East Levee Sacramento River

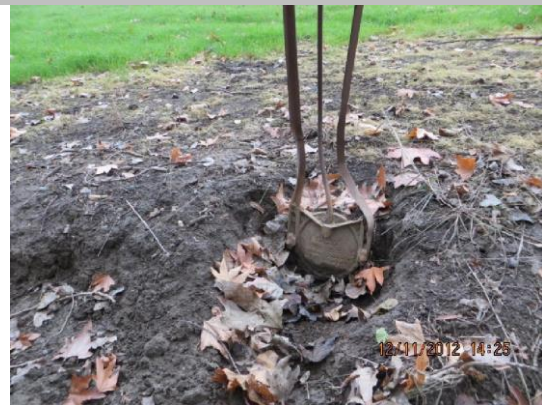
Photo 2 of 3 : UCIP_FA_2015_6087.jpg

view of screwgate on WS toe

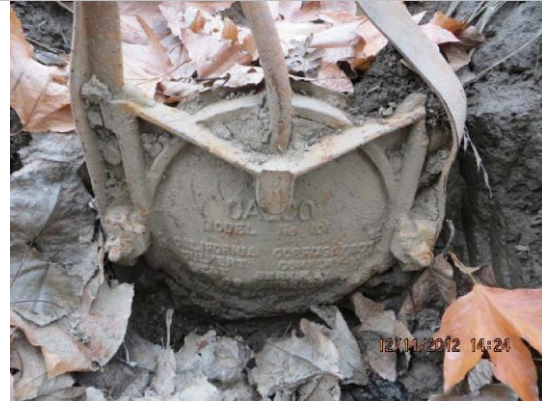
Photo 3 of 3 : UCIP_FA_2015_6088.jpg

view of screwgate on WS toe

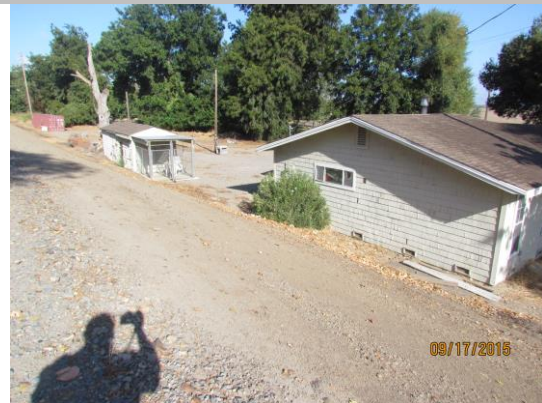
Photo 1 of 1 : FA_2015_ST0003_264_4_20151013_00024.jpg

LM Start	10.27	Rating **	M	Issue No.	4
LM End	10.27	Issue Type +	En	Location *	LS
Category	Earthen Levee			GPS Latitude/Longitude	
				Start	End
Item	Encroachments			39.270431 °	39.270431 °
				-121.999782 °	-121.999782 °
DWR ID	DWR_ST0003_01_s_2012_4				
Action/Comments					
Building

View of the house and dog kennel at the landside toe.

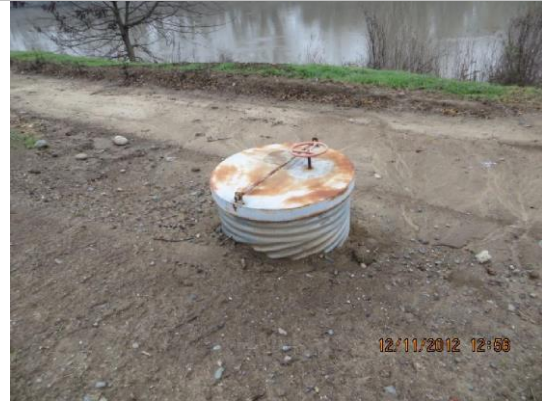
Photo 1 of 2 : UCIP_FA_2015_2778.jpg

Inspector Comments: FS_ID:44447
 DS_ID:17371
 EP_NO: 9517
 FS_HLM: 10.508
 Repair Type: Non-Urgent
 Crossing Status: Found
 UCIP Comments: 4/2/2015 Same as last inspection. Need to verify type of abandonment. Pump house not found on waterside of the levee. Looks abandoned as switch panel found without pump. 7/23/2013 Same as last inspection. 12/18/2013 Same as last inspection. 6/30/2014 Same as last inspection.
 FIELD_STRUCT_DESC: 18-inch steel pipe through the levee, 17.1 feet below the crown. Gate valve and flap gate in concrete distribution box. Water meter in corrugated metal pipe riser at the landward toe and gate valve in corrugated metal pipe on waterside. Pipe was replaced in November 2005. (ABO No. 9517 - Griffin). O&M manual 136, revision May 2011.
 FS Date: 04/15/2015

Waterside view: CMP riser with gate valve

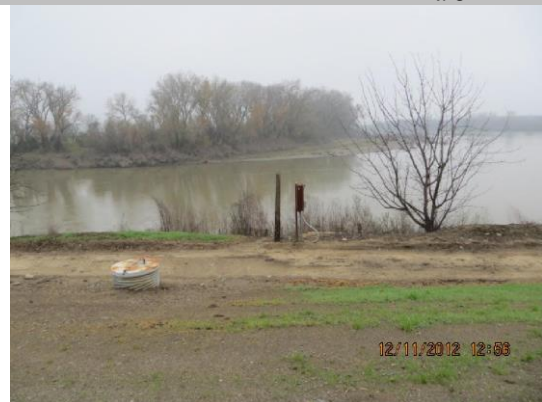
Photo 2 of 2 : UCIP_FA_2015_2779.jpg

Waterside view: CMP riser and abandoned service pole

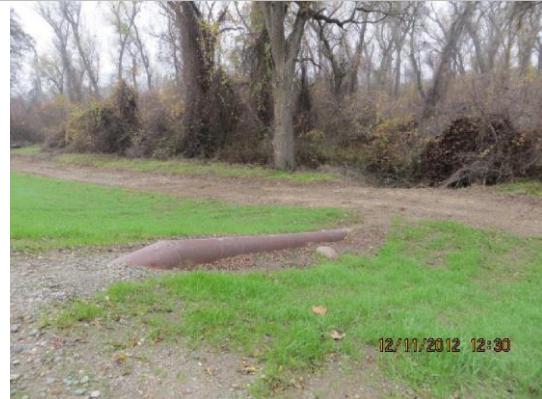
Photo 1 of 2 : UCIP_FA_2015_2780.jpg

LM Start	10.69	Rating **	M	Issue No.	164
LM End	10.69	Issue Type +	En	Location *	LS
Category	Supplemental			GPS Latitude/Longitude	
				Start	End
Item	DWR UCIP Field Study			39.274090 °	39.274090 °
				-122.005263 °	-122.005263 °
DWR ID					
Action/Comments					
Inspector Comments: FS_ID:44449					
DS_ID:17350					
EP_NO: 1369					
FS_HLM: 10.688					
Repair Type: Non-Urgent					
Crossing Status: Found

Waterside view: overview of exposed steel pipe

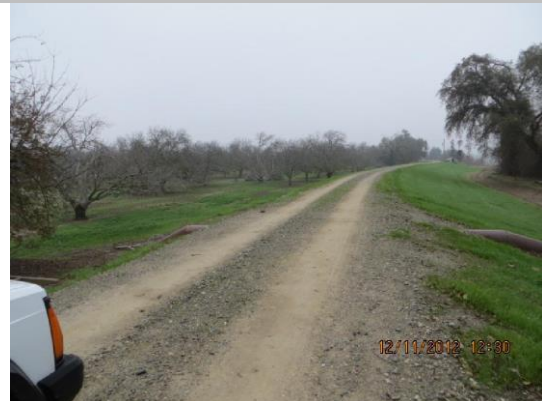
Photo 2 of 2 : UCIP_FA_2015_2781.jpg

Crown view: overview (both sides of the levee)

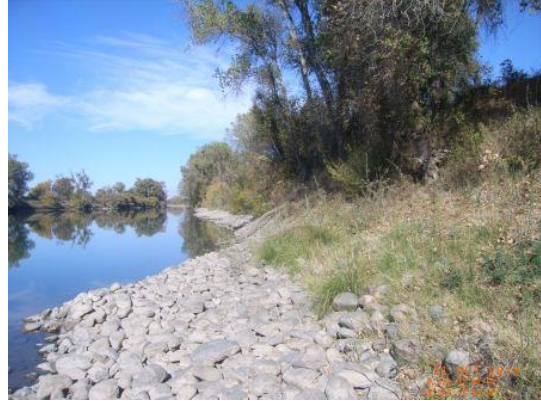
Photo 1 of 1 : USACE2013A_SAC_152-6_L_8.jpg

LM Start	11.53	Rating **	M	Issue No.	8
LM End	11.79	Issue Type +	Ma	Location *	WS
Category	Supplemental			GPS Latitude/Longitude	
				Start	End
Item	2015 USACE Erosion Survey, DRAFT			39.279910 °	39.283853 °
				-122.018221 °	-122.016113 °
DWR ID					
Action/Comments					
Inspector Comments: 2008 - Large rotational/mass failure in the bank with tree slump. 2009 - Minimal new erosion, the tree is leaning further into the river. 2011 - Site extended downstream. 2012 - Minor new erosion and tree roots are further exposed. 2015: Last observed in 2013. [2015 Site ID: SAC_152-6_L]

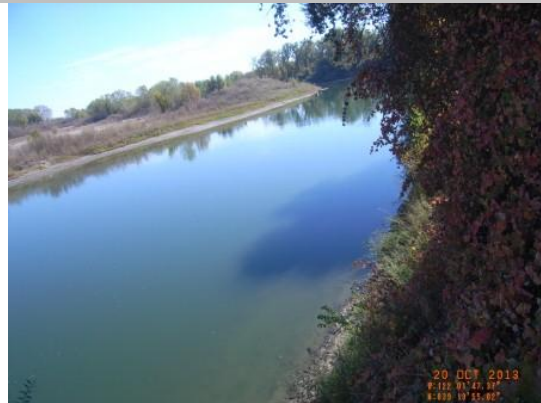
Photo 1 of 1 : USACE2013A_SAC_157-7_R_4.jpg

LM Start	11.85	Rating **	M	Issue No.	1
LM End	11.90	Issue Type +	Ma	Location *	WS
Category	Supplemental			GPS Latitude/Longitude	
				Start	End
Item	2015 USACE Erosion Survey, DRAFT			39.331447 °	39.332716 °
				-122.029440 °	-122.029953 °
DWR ID					
Action/Comments					
Inspector Comments: 2004 - Slowly eroding but near vertical with no vegetation to hold it. 2005 - Erosion is close to levee toe but not into the levee section yet. 2010 - Some new toe scour. 2015: Last observed in 2013. [2015 Site ID: SAC_157-7_R]

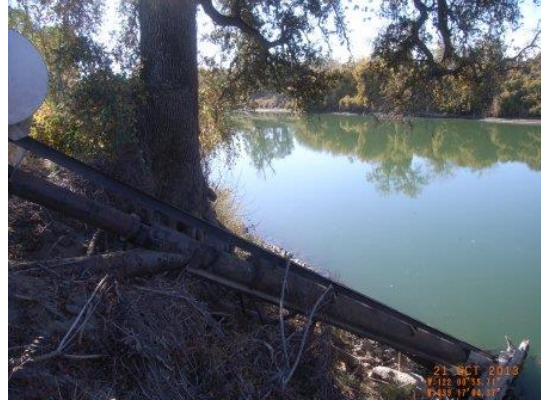
Photo 1 of 1 : USACE2013A_SAC_152-8_L_1.jpg

LM Start	11.85	Rating **	M	Issue No.	13
LM End	11.90	Issue Type +	Ma	Location *	WS
Category	Supplemental			GPS Latitude/Longitude	
				Start	End
Item	2015 USACE Erosion Survey, DRAFT			39.284568 °	39.285298 °
				-122.015690 °	-122.015208 °
DWR ID					
Action/Comments					
Inspector Comments: 2006 - Large rotational/mass failure in the bank with tree slump. Tough clayey toe material. 2007 - Site is between stone revetments with a pump station at the downstream end. 2010 - Erosion is into the levee toe. 2011 - Minor new erosion. 2012 - Minor new erosion. 2015: Last observed in 2013. [2015 Site ID: SAC_152-8_L]

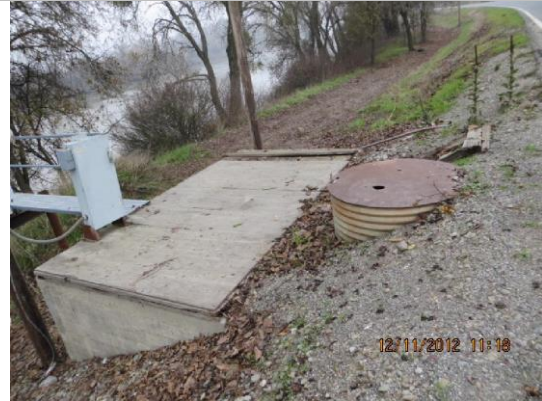
Photo 1 of 3 : UCIP_FA_2015_2608.jpg

Action/Comments					
Inspector Comments: FS_ID:44465 DS_ID:17365 EP_NO: 9514 FS_HLM: 12.058 Repair Type: Non-Urgent Crossing Status: Found UCIP Comments: 4/2/2015 Everything looked to be in good condition. Concrete surge tank still has some silting. Gate valve in CMP riser not visible. Flap gate in concrete distribution box on LS not visible/accessible. Looks cleaning required inside concrete surge tank on WS due to silting. 7/29/2013 Pump running and WS surge tank was full of water so not sure if silt was cleaned out. LS flap gate was visible and is in good condition. 12/30/2013 Same as last inspection. 7/2/2014 Same as last inspection. FIELD_STRUCT_DESC: 36-inch corrugated metal pipe through the levee, 18.1 feet below the crown, pump house on the waterward slope. Gate valve in corrugated metal riser at waterward toe. Flap gate in concrete distribution box at the landward toe. (ABO No. 9514 - Boggs). O&M manual 136, revision May 2011. FS Date: 04/16/2015

Waterside view: pump switch box, surge box & CMP riser

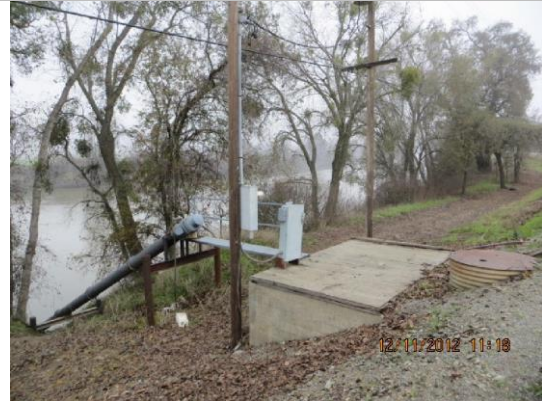
Photo 2 of 3 : UCIP_FA_2015_2609.jpg

Action/Comments					
Inspector Comments: FS_ID:44465 DS_ID:17365 EP_NO: 9514 FS_HLM: 12.058 Repair Type: Non-Urgent Crossing Status: Found UCIP Comments: 4/2/2015 Everything looked to be in good condition. Concrete surge tank still has some silting. Gate valve in CMP riser not visible. Flap gate in concrete distribution box on LS not visible/accessible. Looks cleaning required inside concrete surge tank on WS due to silting. 7/29/2013 Pump running and WS surge tank was full of water so not sure if silt was cleaned out. LS flap gate was visible and is in good condition. 12/30/2013 Same as last inspection. 7/2/2014 Same as last inspection. FIELD_STRUCT_DESC: 36-inch corrugated metal pipe through the levee, 18.1 feet below the crown, pump house on the waterward slope. Gate valve in corrugated metal riser at waterward toe. Flap gate in concrete distribution box at the landward toe. (ABO No. 9514 - Boggs). O&M manual 136, revision May 2011. FS Date: 04/16/2015

Waterside view: steel pipe, pump, surge box & CMP riser

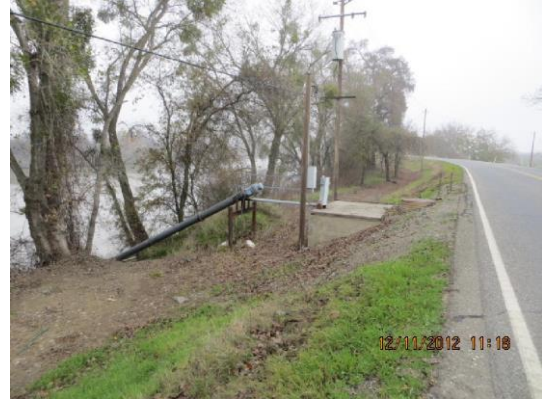
Photo 3 of 3 : UCIP_FA_2015_2610.jpg

Action/Comments					
Inspector Comments: FS_ID:44465 DS_ID:17365 EP_NO: 9514 FS_HLM: 12.058 Repair Type: Non-Urgent Crossing Status: Found UCIP Comments: 4/2/2015 Everything looked to be in good condition. Concrete surge tank still has some silting. Gate valve in CMP riser not visible. Flap gate in concrete distribution box on LS not visible/accessible. Looks cleaning required inside concrete surge tank on WS due to silting. 7/29/2013 Pump running and WS surge tank was full of water so not sure if silt was cleaned out. LS flap gate was visible and is in good condition. 12/30/2013 Same as last inspection. 7/2/2014 Same as last inspection. FIELD_STRUCT_DESC: 36-inch corrugated metal pipe through the levee, 18.1 feet below the crown, pump house on the waterward slope. Gate valve in corrugated metal riser at waterward toe. Flap gate in concrete distribution box at the landward toe. (ABO No. 9514 - Boggs). O&M manual 136, revision May 2011. FS Date: 04/16/2015

Waterside view: overview pipe, pump, surge box & CMP riser

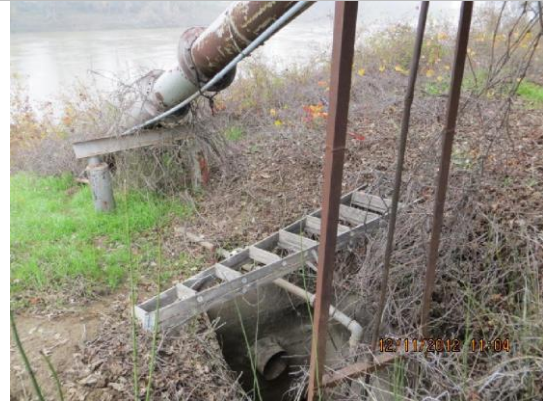
Photo 1 of 3 : UCIP_FA_2015_2611.jpg

Action/Comments					
Inspector Comments: FS_ID:44466					
DS_ID:17366					
EP_NO: 9513					
FS_HLM: 12.429					
Repair Type: Urgent					
Crossing Status: Found					
UCIP Comments: 4/2/2015 2.5in pipe is still present and prevents the slide gate from fully closing. A 2.5 inch GI pipe through 36 inch CMP found. A 2 inch electrical conduit also found. 7/29/2013 2.5in. GI pipe and chain in WS surge box will prevent slide gate from closing fully for high water season. 12/30/2013 Same as last inspection. 7/2/2014 2.5in. GI pipe and chain in WS surge box will prevent slide gate from closing fully for high water season.					
FIELD_STRUCT_DESC: 24-inch corrugated metal pipe through the levee. Slide gate in concrete surge box on berm. Slant pump on riverbank. Pipe invert 16.5 ft below crown. Concrete distribution box at the landward toe. (ABO No. 9513 -Boggs). O&M manual 136, revision May 2011.					
FS Date: 04/16/2015

Waterside view: steel pipe, GI pipe in concrete surge box

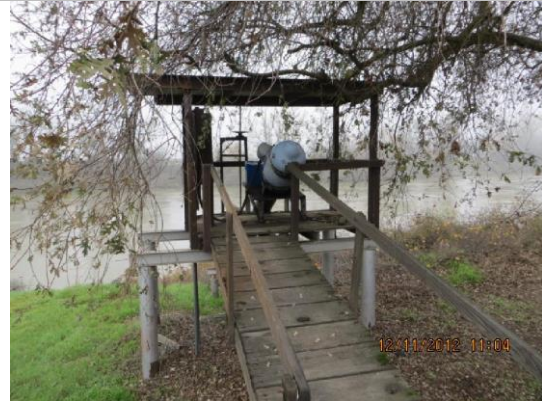
Photo 2 of 3 : UCIP_FA_2015_2612.jpg

UCIP Comments: 4/2/2015 2.5in pipe is still present and prevents the slide gate from fully closing. A 2.5 inch GI pipe through 36 inch CMP found. A 2 inch electrical conduit also found. 7/29/2013 2.5in. GI pipe and chain in WS surge box will prevent slide gate from closing fully for high water season. 12/30/2013 Same as last inspection. 7/2/2014 2.5in. GI pipe and chain in WS surge box will prevent slide gate from closing fully for high water season.

Waterside view: pump station and walkway

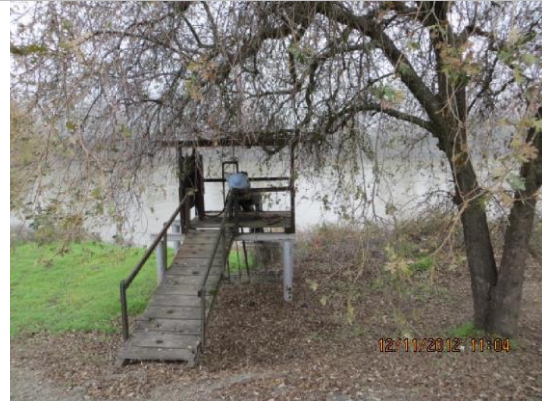
Photo 3 of 3 : UCIP_FA_2015_2613.jpg

Action/Comments					
Inspector Comments: FS_ID:44466 DS_ID:17366 EP_NO: 9513 FS_HLM: 12.429 Repair Type: Urgent Crossing Status: Found UCIP Comments: 4/2/2015 2.5in pipe is still present and prevents the slide gate from fully closing. A 2.5 inch GI pipe through 36 inch CMP found. A 2 inch electrical conduit also found. 7/29/2013 2.5in. GI pipe and chain in WS surge box will prevent slide gate from closing fully for high water season. 12/30/2013 Same as last inspection. 7/2/2014 2.5in. GI pipe and chain in WS surge box will prevent slide gate from closing fully for high water season. FIELD_STRUCT_DESC: 24-inch corrugated metal pipe through the levee. Slide gate in concrete surge box on berm. Slant pump on riverbank. Pipe invert 16.5 ft below crown. Concrete distribution box at the landward toe. (ABO No. 9513 -Boggs). O&M manual 136, revision May 2011. FS Date: 04/16/2015

Waterside view: overview of slanted pump and shed

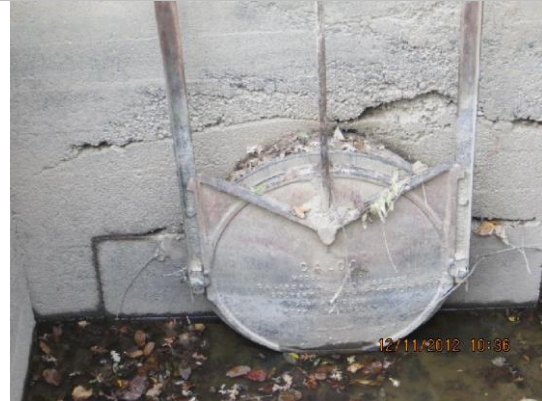
Photo 1 of 3 : UCIP_FA_2015_2614.jpg

Inspector Comments: FS_ID:44468
 DS_ID:17367
 EP_NO: 2971
 FS_HLM: 12.559
 Repair Type: Urgent
 Crossing Status: Found
 UCIP Comments: 4/2/2015 Pipe has as small leak during times of high water. Not sure of the cause.- Pumps taken out from the pipe (may be for repairs). Only control board found.- LS wing wall minor damage.7/23/2013 Pump motors attached to pipes and running. Think pumps were disconnected during last inspection to keep motors above water for high water season.12/19/2013 Same as last inspection.7/2/2014 Same as last inspection.
 FIELD_STRUCT_DESC: 36-inch corrugate metal pipe through the levee, 20.0 feet below the crown. Slide gate at the waterward end. Two slant pumps on bank discharging into concrete distribution box at the waterward toe. Switch panel on the waterward side. (App. No. 2971 - Terhel). O&M manual 136, revision May 2011.
 FS Date: 04/16/2015

Waterside view: slide gate in concrete surge box

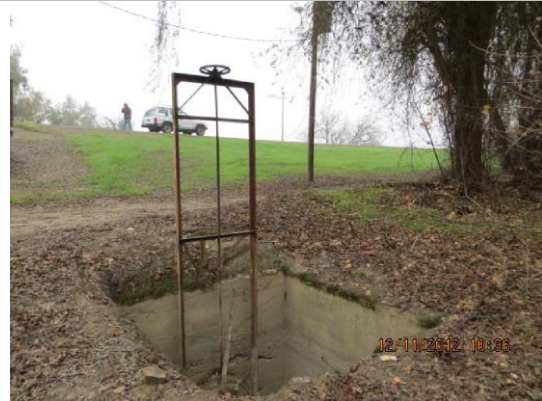
Photo 2 of 3 : UCIP_FA_2015_2615.jpg

Item	DWR UCIP Field Study			39.294449 °	39.294449 °	
				-122.013871 °	-122.013871 °	
DWR ID						
Action/Comments						
Inspector Comments: FS_ID:44468 DS_ID:17367 EP_NO: 2971 FS_HLM: 12.559 Repair Type: Urgent Crossing Status: Found UCIP Comments: 4/2/2015 Pipe has as small leak during times of high water. Not sure of the cause.- Pumps taken out from the pipe (may be for repairs). Only control board found.- LS wing wall minor damage.7/23/2013 Pump motors attached to pipes and running. Think pumps were disconnected during last inspection to keep motors above water for high water season.12/19/2013 Same as last inspection.7/2/2014 Same as last inspection. FIELD_STRUCT_DESC: 36-inch corrugate metal pipe through the levee, 20.0 feet below the crown. Slide gate at the waterward end. Two slant pumps on bank discharging into concrete distribution box at the waterward toe. Switch panel on the waterward side. (App. No. 2971 - Terhel). O&M manual 136, revision May 2011. FS Date: 04/16/2015

Waterside view: concrete surge box

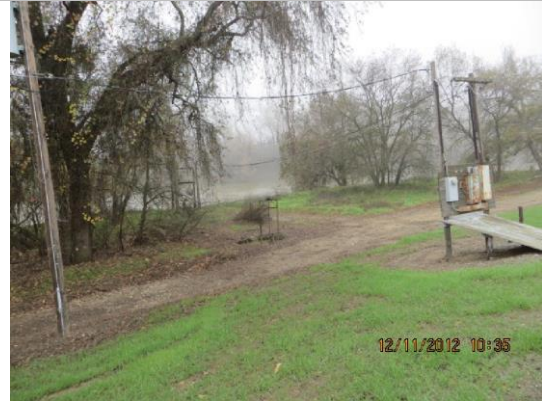
Photo 3 of 3 : UCIP_FA_2015_2616.jpg

Action/Comments					
Inspector Comments: FS_ID:44468 DS_ID:17367 EP_NO: 2971 FS_HLM: 12.559 Repair Type: Urgent Crossing Status: Found UCIP Comments: 4/2/2015 Pipe has as small leak during times of high water. Not sure of the cause.- Pumps taken out from the pipe (may be for repairs). Only control board found.- LS wing wall minor damage.7/23/2013 Pump motors attatched to pipes and running. Think pumps were disconnected during last inspection to keep motors above water for high water season.12/19/2013 Same as last inspection.7/2/2014 Same as last inspection. FIELD_STRUCT_DESC: 36-inch corrugate metal pipe through the levee, 20.0 feet below the crown. Slide gate at the waterward end. Two slant pumps on bank discharging into concrete distribution box at the waterward toe. Switch panel on the waterward side. (App. No. 2971 - Terhel). O&M manual 136, revision May 2011. FS Date: 04/16/2015

Waterside view: overview

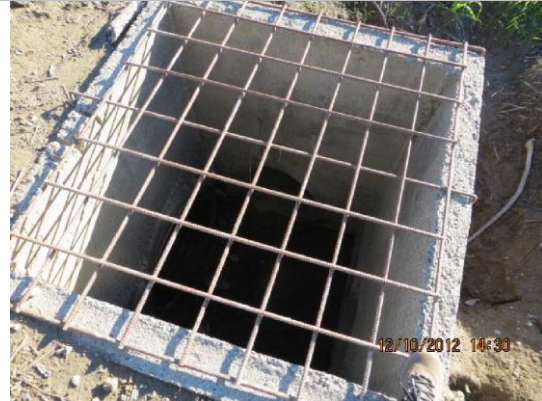
Photo 1 of 3 : UCIP_FA_2015_2625.jpg

Action/Comments					
Inspector Comments: FS_ID:44473 DS_ID:17369 EP_NO: 9510 FS_HLM: 12.962 Repair Type: Urgent Crossing Status: Found UCIP Comments: 4/2/2015 Pipe leaks during high water. It is suspected that the screw gate does not fully close and may need to be cleaned to allow it to close fully. Soil erosion around CMP riser and surge concrete box on WS damaged due to overflow. Pump not found. Flap gate missing on WS concrete box. WS slope eroded. Structure might have been used as drainage structure. This needs to be determined during routine inspection. 7/23/2013 Water was flowing from the WS to LS ditch. Not sure where water flow was originating. All erosion problems are still present. 12/19/2013 Same as last inspection. 7/2/2014 Same as last inspection. FIELD_STRUCT_DESC: 36-inch corrugated metal pipe through the levee, 18.0 feet below the crown. Slide gate in 36-inch corrugated metal riser on the waterward slope. Concrete box on the waterward side. Pump mounted on waterward bank. (ABO No. 9510 Forry). O&M manual 136, revision May 2011. FS Date: 04/16/2015

Waterside view: concrete surge box

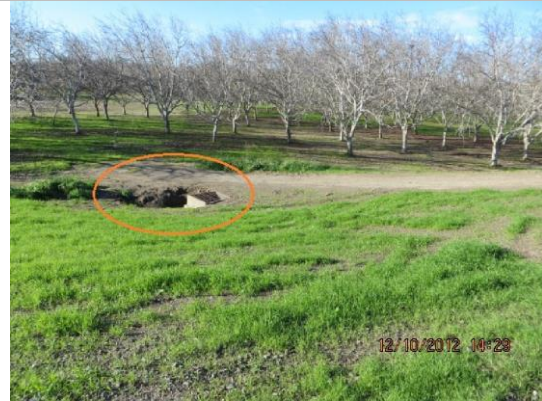
Photo 2 of 3 : UCIP_FA_2015_2626.jpg

UCIP Comments: 4/2/2015 Pipe leaks during high water. It is suspected that the screw gate does not fully close and may need to be cleaned to allow it to close fully. Soil erosion around CMP riser and surge concrete box on WS damaged due to overflow. Pump not found. Flap gate missing on WS concrete box. WS slope eroded. Structure might have been used as drainage structure. This needs to be determined during routine inspection. 7/23/2013 Water was flowing from the WS to LS ditch. Not sure where water flow was originating. All erosion problems are still present. 12/19/2013 Same as last inspection. 7/2/2014 Same as last inspection.

Waterside view: overview of concrete surge box

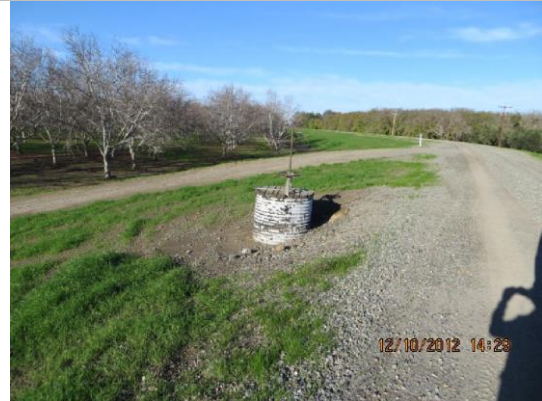
Photo 3 of 3 : UCIP_FA_2015_2627.jpg

Action/Comments					
Inspector Comments: FS_ID:44473 DS_ID:17369 EP_NO: 9510 FS_HLM: 12.962 Repair Type: Urgent Crossing Status: Found UCIP Comments: 4/2/2015 Pipe leaks during high water. It is suspected that the screw gate does not fully close and may need to be cleaned to allow it to close fully. Soil erosion around CMP riser and surge concrete box on WS damaged due to overflow. Pump not found. Flap gate missing on WS concrete box. WS slope eroded. Structure might have been used as drainage structure. This needs to be determined during routine inspection. 7/23/2013 Water was flowing from the WS to LS ditch. Not sure where water flow was originating. All erosion problems are still present. 12/19/2013 Same as last inspection. 7/2/2014 Same as last inspection. FIELD_STRUCT_DESC: 36-inch corrugated metal pipe through the levee, 18.0 feet below the crown. Slide gate in 36-inch corrugated metal riser on the waterward slope. Concrete box on the waterward side. Pump mounted on waterward bank. (ABO No. 9510 Forry). O&M manual 136, revision May 2011. FS Date: 04/16/2015

Waterside view: CMP riser on levee slope.

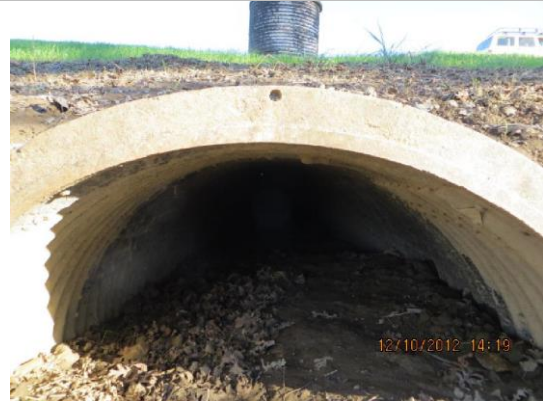
Photo 1 of 3 : UCIP_FA_2015_2577.jpg

Inspector Comments: FS_ID:44474
 DS_ID:17340
 EP_NO: N/A
 FS_HLM: 13.373
 Repair Type: Non-Urgent
 Crossing Status: Found
 UCIP Comments: 4/2/2015 Pipe has been selected for internal camera inspection. Outlet pipe silted on WS. Inlet structure damaged on LS. Not properly abandoned. 7/23/2013 Same as last inspection. 12/19/2013 Same as last inspection. 7/2/2014 Same as last inspection.
 FIELD_STRUCT_DESC: Abandoned 48-inch corrugated metal drainpipe through the levee, 16.5 feet below the crown. Slide gate in 60-inch corrugated metal pipe riser on the waterward slope. Landward end of pipe on east side of River Road. O&M manual 136, revision May 2011.
 FS Date: 04/16/2015

Waterside view: silted concrete lined CMP outlet pipe

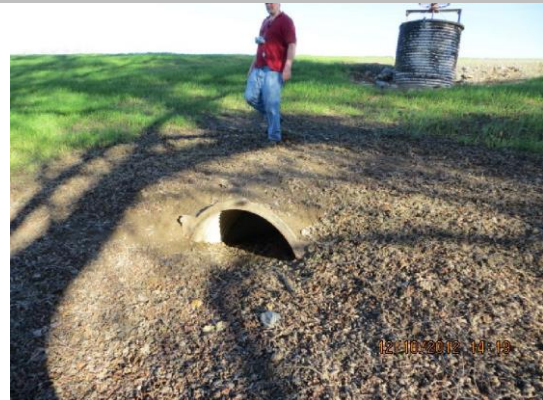
Photo 2 of 3 : UCIP_FA_2015_2578.jpg

Waterside view: overview of CMP riser and outlet pipe

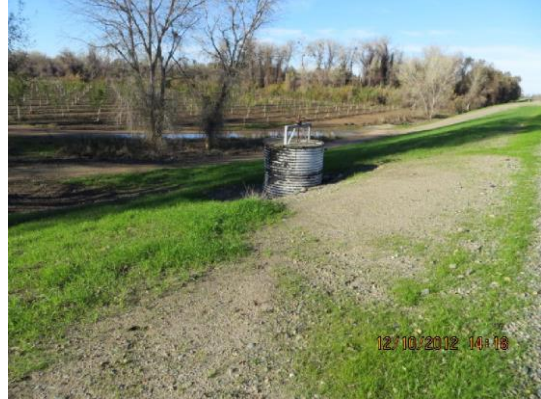
Photo 3 of 3 : UCIP_FA_2015_2579.jpg

Waterside view: CMP riser with slide gate

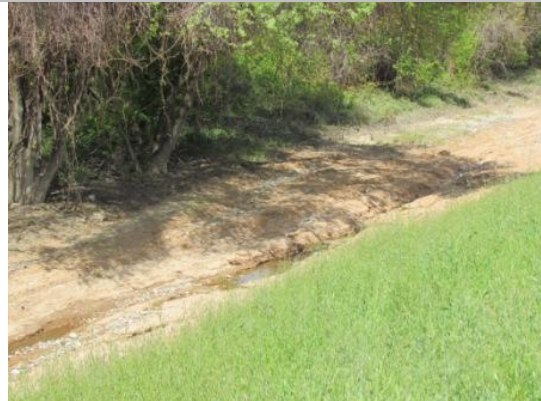
Photo 1 of 1 : FA_2015_ST0003_264_9_20150910_00002.jpg

LM Start	13.47	Rating **	M	Issue No.	9
LM End	13.66	Issue Type +	Ma	Location *	WS
Category	Earthen Levee			GPS Latitude/Longitude	
				Start	End
Item	Erosion / Bank Caving			39.307448 °	39.310231 °
				-122.013037 °	-122.012912 °
DWR ID	DWR_ST0003_01_s_2012_9				
Action/Comments					
Note and monitor erosion site.

View of the erosion along the W/S toe.

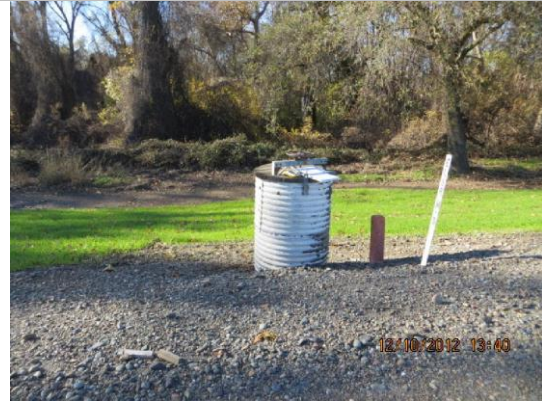
Photo 1 of 3 : UCIP_FA_2015_2617.jpg

Inspector Comments: FS_ID:44477
 DS_ID:17330
 EP_NO: N/A
 FS_HLM: 14.493
 Repair Type: Non-Urgent
 Crossing Status: Found
 UCIP Comments: 4/2/2015 Same as last inspection. Concrete box on LS silted in. If abandoned it should be done so properly. 7/23/2013 Same as last inspection. 12/19/2013 Same as last inspection. 7/2/2014 Same as last inspection.
 FIELD_STRUCT_DESC: 24-inch corrugated metal pipe through the levee, 14.0 feet below the crown. Slide gate in corrugated metal pipe riser on the waterward slope. Concrete distribution box at the landward side. O&M manual 136, revision May 2011.
 FS Date: 04/16/2015

Waterside view: CMP riser with slide gate

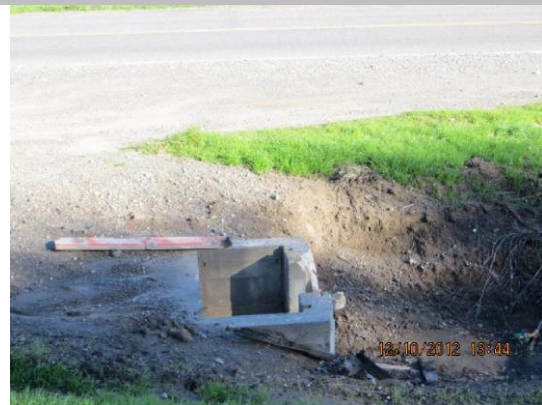
Photo 2 of 3 : UCIP_FA_2015_2618.jpg

Landside view: overview of distribution box

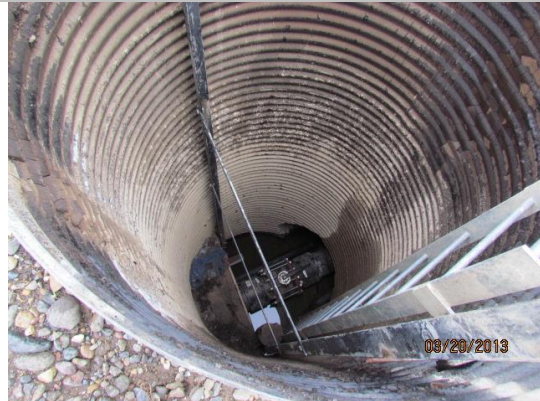
Photo 1 of 1 : FA_2015_ST0003_264_25_20150910_00010.jpg

LM Start	14.56	Rating **	U	Issue No.	25
LM End	14.56	Issue Type +	En	Location *	WS
Category	Earthen Levee			GPS Latitude/Longitude	
				Start	End
Item	Encroachments			39.322254 °	39.322254 °
				-122.015985 °	-122.015985 °
DWR ID	DWR_ST0003_01_s_2013_25				
Action/Comments					
Pipe

View of the unauthorized pipe placed inside the drain pipe.

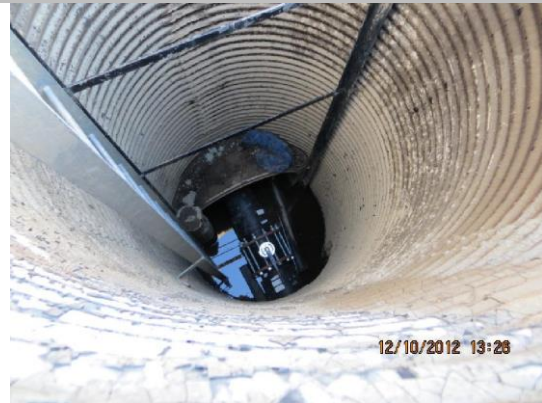
Photo 1 of 2 : UCIP_FA_2015_2620.jpg

Action/Comments					
Inspector Comments: FS_ID:44478					
DS_ID:17331					
EP_NO: 1833					
FS_HLM: 14.551					
Repair Type: Urgent					
Crossing Status: Found					
UCIP Comments: 4/2/2015 Leaks during high water.- Distribution box plugged with cement concrete on LS. Other concrete box plugged with concrete on WS. New steel pipe (about 16 inch diameter) sleeved through CMP pipe. It is visible inside CMP riser.7/23/2013 Same as last inspection.12/19/2013 Same as last inspection.7/2/2014 Same as last inspection.					
FIELD_STRUCT_DESC: 42-inch corrugated metal pipe through the levee, 14.2 feet below the crown. Pump structure on the riverbank. Concrete surge box at the waterward toe. Slide gate in corrugated metal pipe riser on the waterward slope. Concrete distribution box on the landward side across River Road. (App. No. 1833 - Westfall). O&M manual 136, revision May 2011.					
FS Date: 04/16/2015

Waterside view: new steel pipe sleeved through CMP pipe.

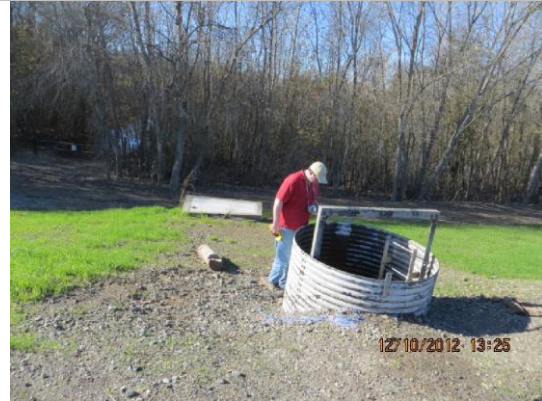
Photo 2 of 2 : UCIP_FA_2015_2621.jpg

Waterside view: CMP riser with slide gate and surge box

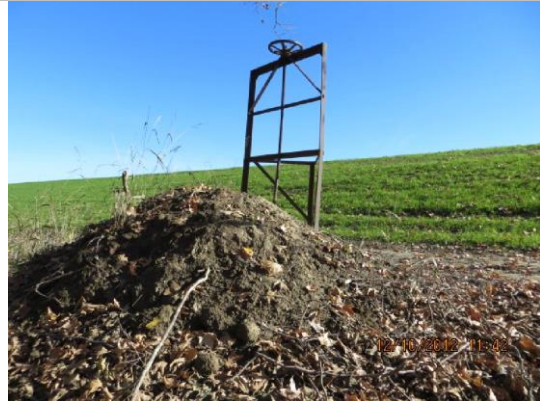
Photo 1 of 3 : UCIP_FA_2015_2622.jpg

Inspector Comments: FS_ID:44485
 DS_ID:17349
 EP_NO: N/A
 FS_HLM: 16.421
 Repair Type: Non-Urgent
 Crossing Status: Indicator Found
 UCIP Comments: 4/2/2015 WS slide gate and LS distribution box are still silted over. Seems abandoned as slide gate and distribution box silted. 7/23/2013 Same as last inspection. 12/19/2013 Same as last inspection. 7/2/2014 Same as last inspection.
 FIELD_STRUCT_DESC: Abandoned 48-inch corrugated metal irrigation and drain pipe through the levee, 17.0 feet below the crown. Slide gate on the waterward end. 8-inch steel pipe sleeved through the 48-inch pipe during the summer months. Discharges into concrete distribution box at the landward toe. O&M manual 136, revision May 2011.
 FS Date: 04/16/2015

Waterside view: silt and debris in front of slide gate

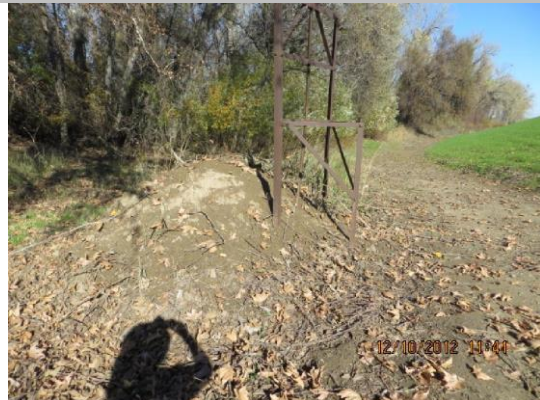
Photo 2 of 3 : UCIP_FA_2015_2623.jpg

Waterside view: slide gate on steel structure

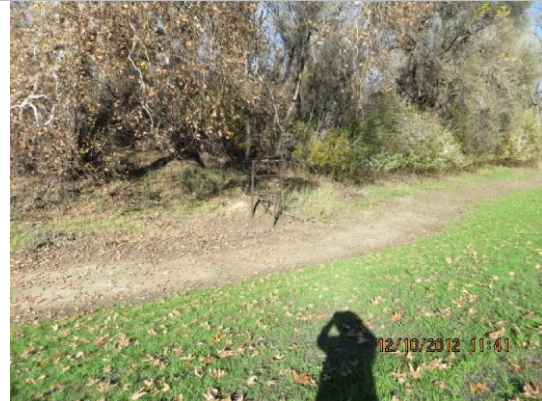
Photo 3 of 3 : UCIP_FA_2015_2624.jpg

Waterside view: overview of slide gate

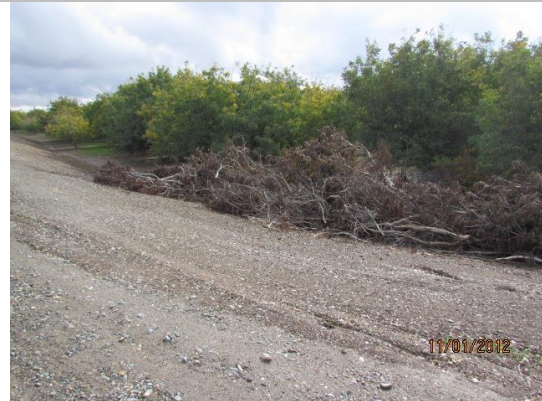
Photo 1 of 1 : FA_2015_ST0003_264_36_20150910_00015.jpg

View of the brush pile along the landside toe.

LM Start	16.95	Rating **	M	Issue No.	36
LM End	16.95	Issue Type +	En	Location *	LS
Category	Earthen Levee			GPS Latitude/Longitude	
				Start	End
Item	Encroachments			39.347308 °	39.347308
				-122.015264 °	-122.015264
DWR ID	DWR_ST0003_01_f_2012_36				
Action/Comments					
Prunings					
Inspector Comments: Remove the pruning from the landside toe.

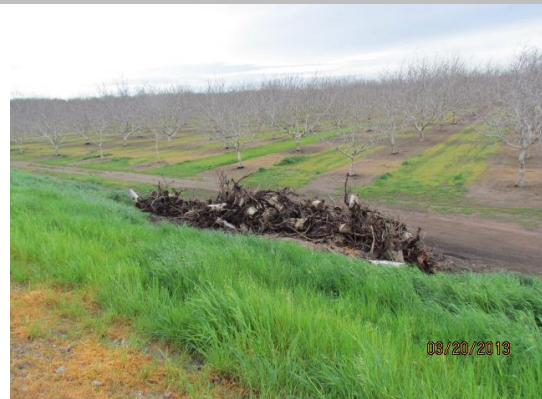
Photo 1 of 1 : FA_2015_ST0003_264_30_20150910_00014.jpg

View of the walnut orchard stumps along the landside toe.

LM Start	17.42	Rating **	M	Issue No.	30
LM End	17.42	Issue Type +	En	Location *	LS
Category	Earthen Levee			GPS Latitude/Longitude	
				Start	End
Item	Encroachments			39.351311 °	39.351311 °
				-122.009409 °	-122.009409 °
DWR ID	DWR_ST0003_01_s_2013_30				
Action/Comments					
Prunings					
Inspector Comments: Remove the prunings from the landside toe.

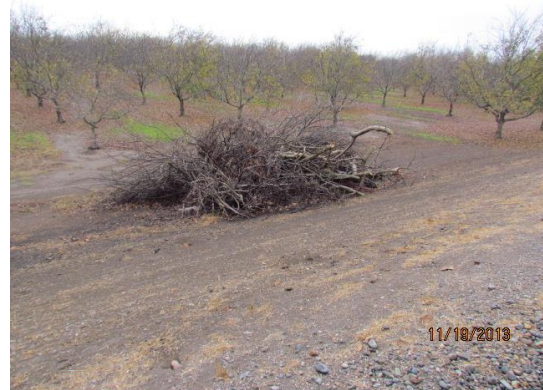
Photo 1 of 1 : FA_2015_ST0003_264_136_20150910_00021.jpg

View of the prunings at the toe of the levee.

LM Start	17.43	Rating **	M	Issue No.	136
LM End	17.43	Issue Type +	En	Location *	LS
Category	Earthen Levee			GPS Latitude/Longitude	
				Start	End
Item	Encroachments			39.351447 °	39.351447 °
				-122.009385 °	-122.009385 °
DWR ID	DWR_ST0003_01_f_2013_136				
Action/Comments					
Prunings					
Inspector Comments: Remove the prunings from the landside toe.

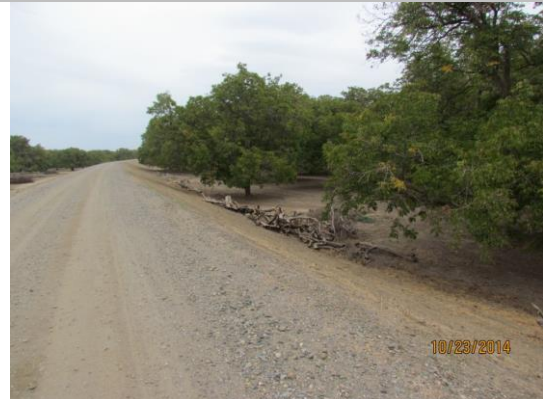
Photo 1 of 1 : FA_2015_ST0003_264_58_20150910_00020.jpg

View of the firewood along the landside slope.

LM Start	17.67	Rating **	M	Issue No.	58
LM End	17.74	Issue Type +	En	Location *	LS
Category	Earthen Levee			GPS Latitude/Longitude	
				Start	End
Item	Encroachments			39.354862 °	39.355885 °
				-122.009292 °	-122.009030 °
DWR ID	DWR_ST0003_01_f_2014_58				
Action/Comments					
Firewood					
Inspector Comments: Remove the firewood for the landside toe.

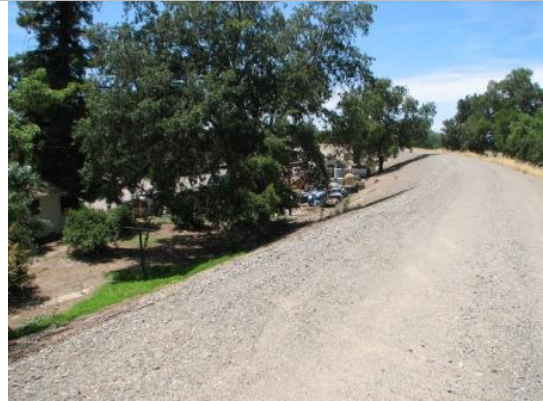
Photo 1 of 1 : FA_2015_ST0003_264_16_20150910_00007.jpg

LM Start	18.01	Rating **	U	Issue No.	16
LM End	18.15	Issue Type +	En	Location *	LS
Category	Earthen Levee			GPS Latitude/Longitude	
				Start	End
Item	Encroachments			39.359188 °	39.359980 °
				-122.006878 °	-122.004517 °
DWR ID	DWR_ST0003_01_s_2012_16				
Action/Comments					
Equipment					
Inspector Comments: Remove the equipment from the landside toe.

View of the equipment and trees next to the landside toe of the levee.

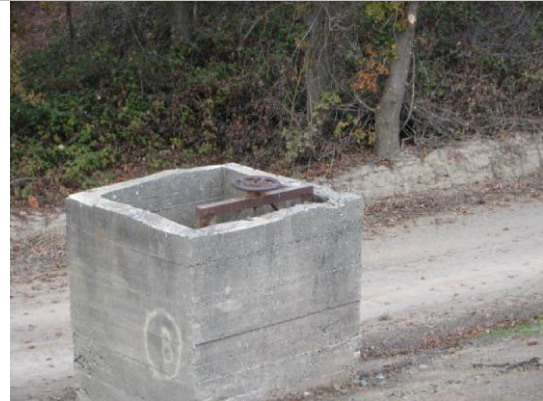
Photo 1 of 3 : UCIP_FA_2015_2642.jpg

Action/Comments					
Inspector Comments: FS_ID:44491 DS_ID:17343 EP_NO: 9502 FS_HLM: 18.222 Repair Type: Non-Urgent Crossing Status: Found UCIP Comments: 4/2/2015 Same as last inspection. Vertical pump on bank not found as bank is not accessible. An abandoned electrical switch found on waterside. Landside distribution box is filled with debris and soil. Crossing appears abandoned and should be verified as having been done so properly. 7/24/2013 Same as last inspection. 12/19/2013 Same as last inspection. 7/2/2014 Same as last inspection. FIELD_STRUCT_DESC: 36-inch corrugated metal pipe through the levee, 18.0 feet below the crown. Vertical pump on bank. Slide gate in concrete box at the waterward toe. Discharges into concrete distribution box at the landward toe. Pole on the waterward shoulder. (ABO No. 9502 - Coffman, and Application No. 11540). O&M manual 136, revision May 2011. FS Date: 04/16/2015

Waterside view: concrete gate riser

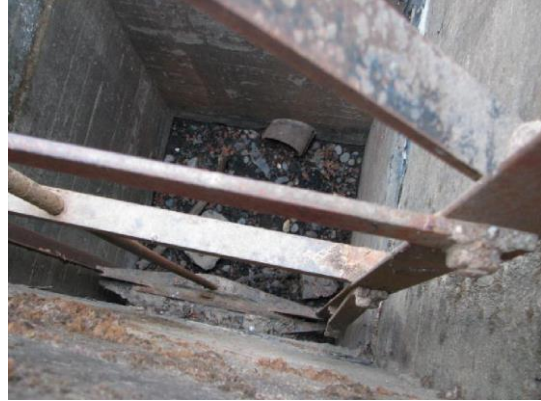
Photo 2 of 3 : UCIP_FA_2015_2643.jpg

Action/Comments					
Inspector Comments: FS_ID:44491 DS_ID:17343 EP_NO: 9502 FS_HLM: 18.222 Repair Type: Non-Urgent Crossing Status: Found UCIP Comments: 4/2/2015 Same as last inspection. Vertical pump on bank not found as bank is not accessible. An abandoned electrical switch found on waterside. Landside distribution box is filled with debris and soil. Crossing appears abandoned and should be verified as having been done so properly. 7/24/2013 Same as last inspection. 12/19/2013 Same as last inspection. 7/2/2014 Same as last inspection. FIELD_STRUCT_DESC: 36-inch corrugated metal pipe through the levee, 18.0 feet below the crown. Vertical pump on bank. Slide gate in concrete box at the waterward toe. Discharges into concrete distribution box at the landward toe. Pole on the waterward shoulder. (ABO No. 9502 - Coffman, and Application No. 11540). O&M manual 136, revision May 2011. FS Date: 04/16/2015

Waterside view: inside gate riser

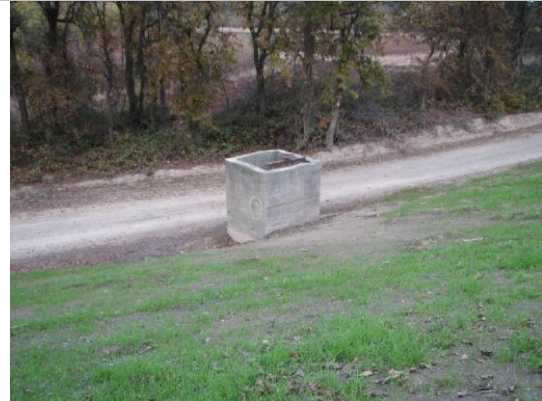
Photo 3 of 3 : UCIP_FA_2015_2644.jpg

LM Start	18.19	Rating **	M	Issue No.	178 (cont)
LM End	18.19	Issue Type +	En	Location *	LS
Category	Supplemental			GPS Latitude/Longitude	
				Start	End
Item	DWR UCIP Field Study			39.359983 °	39.359983 °
				-122.003732 °	-122.003732 °
DWR ID					
Action/Comments					
Inspector Comments: FS_ID:44491 DS_ID:17343 EP_NO: 9502 FS_HLM: 18.222 Repair Type: Non-Urgent Crossing Status: Found UCIP Comments: 4/2/2015 Same as last inspection. Vertical pump on bank not found as bank is not accessible. An abandoned electrical switch found on waterside. Landside distribution box is filled with debris and soil. Crossing appears abandoned and should be verified as having been done so properly. 7/24/2013 Same as last inspection.12/19/2013 Same as last inspection.7/2/2014 Same as last inspection. FIELD_STRUCT_DESC: 36-inch corrugated metal pipe through the levee, 18.0 feet below the crown. Vertical pump on bank. Slide gate in concrete box at the waterward toe. Discharges into concrete distribution box at the landward toe. Pole on the waterward shoulder. (ABO No. 9502 - Coffman, and Application No. 11540). O&M manual 136, revision May 2011. FS Date: 04/16/2015

Waterside view: overview of gate riser

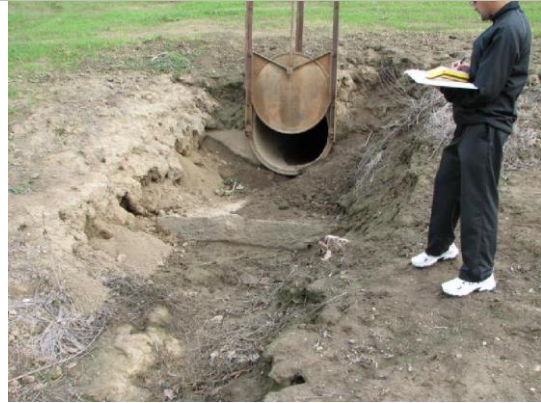
Photo 1 of 2 : UCIP_FA_2015_2645.jpg

LM Start	18.61	Rating **	U	Issue No.	180
LM End	18.61	Issue Type +	En	Location *	LS
Category	Supplemental			GPS Latitude/Longitude	
				Start	End
Item	DWR UCIP Field Study			39.362866 °	39.362866 °
				-121.997993 °	-121.997993 °
DWR ID					
Action/Comments					
Inspector Comments: FS_ID:44494 DS_ID:17345 EP_NO: N/A FS_HLM: 18.653 Repair Type: Urgent Crossing Status: Found UCIP Comments: 4/2/2015 Same as last inspection. Pipe has been selected for internal camera inspection.Sloughing at outlet and levee slope is damaged due to sloughing.7/24/2013 Same as last inspection.12/19/2013 Same as last inspection.7/2/2014 It is not an abandoned crossing. Sloughing at outlet and levee slope is damaged due to sloughing. FIELD_STRUCT_DESC: A 36- inch corrugated metal drainpipe through the levee, 20.0 feet below the crown. Slide gate at the waterward toe. O&M manual 136, revision May 2011. FS Date: 04/16/2015

Waterside view: outlet pipe with concrete headwall and floor apron.

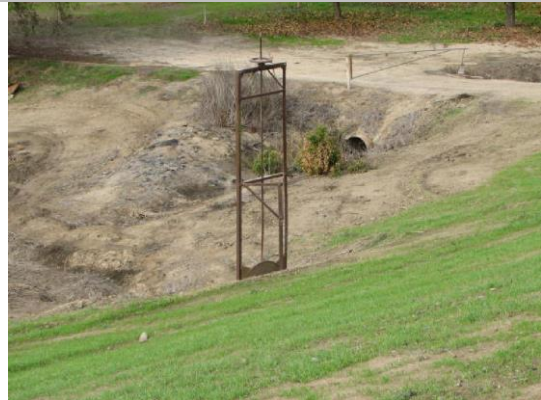
Photo 2 of 2 : UCIP_FA_2015_2646.jpg

Waterside view: overview of sliding gate structure

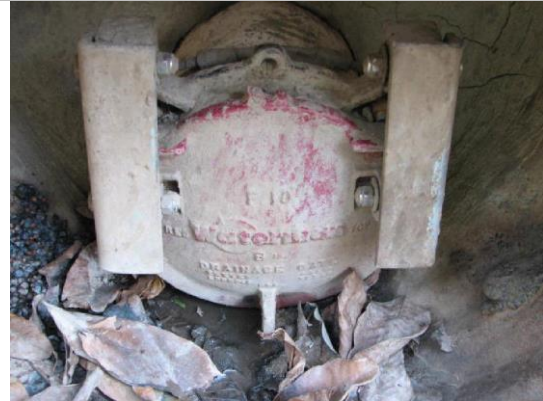
Photo 1 of 3 : UCIP_FA_2015_2647.jpg

LM Start	18.70	Rating **	M	Issue No.	181
LM End	18.70	Issue Type +	En	Location *	LS
Category	Supplemental			GPS Latitude/Longitude	
				Start	End
Item	DWR UCIP Field Study			39.364067 °	39.364067 °
				-121.997792 °	-121.997792 °
DWR ID					
Action/Comments					
Inspector Comments: FS_ID:44495					
DS_ID:17346					
EP_NO: N/A					
FS_HLM: 18.74					
Repair Type: Non-Urgent					
Crossing Status: Found

Waterside view: 8-inch pipe and drain gate

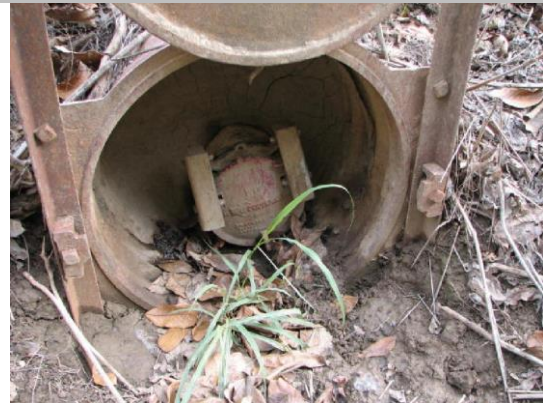
Photo 2 of 3 : UCIP_FA_2015_2648.jpg

Waterside view: 8-inch pipe inside 24-inch CMP

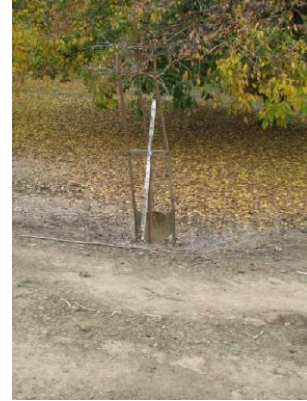
Photo 3 of 3 : UCIP_FA_2015_2649.jpg

LM Start	18.70	Rating **	M	Issue No.	181 (cont)
LM End	18.70	Issue Type +	En	Location *	LS
Category	Supplemental			GPS Latitude/Longitude	
				Start	End
Item	DWR UCIP Field Study			39.364067 °	39.364067 °
				-121.997792 °	-121.997792 °
DWR ID					
Action/Comments					
Inspector Comments: FS_ID:44495 DS_ID:17346 EP_NO: N/A FS_HLM: 18.74 Repair Type: Non-Urgent Crossing Status: Found

Waterside view: overview of slide gate structure

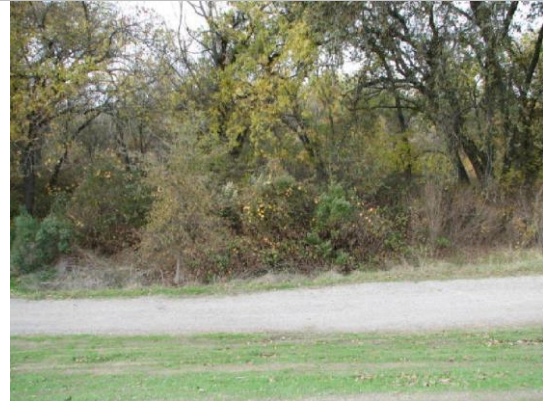
Photo 2 of 2 : UCIP_FA_2015_2651.jpg

Inspector Comments: FS_ID:44500
DS_ID:17487
EP_NO: N/A
FS_HLM: 19.615
Repair Type: Non-Urgent
Crossing Status: Found
UCIP Comments: 4/2/2015 Same as last inspection. Slide Gate WS not found. An abandoned pump and steel pipe found on WS. A 6 ft x 8 ft concrete distribution box with a CMP found on LS. Box filled with soil. An abandoned crossing. 7/24/2013 Same as last inspection. 12/19/2013 Same as last inspection. 7/2/2014 Same as last inspection.
FIELD_STRUCT_DESC: 36 inch pipe, 21.7 ft invert below crown. O&M manual 136, revision May 2011.
FS Date: 04/16/2015

Waterside view: overview

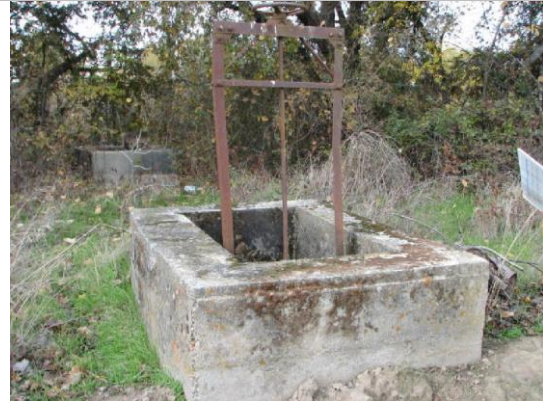
Photo 2 of 3 : UCIP_FA_2015_2653.jpg

UCIP Comments: 4/2/2015 Same as last inspection. Only one pump found on WS. An abandoned surge box found on WS and pipe is grouted with cement. Two 16-inch steel pipe found on pump station along with two electrical conduits. A concrete distribution box found on LS with 20-inch CMP. Appears abandoned crossing. 7/24/2013 Same as last inspection. 12/19/2013 Same as last inspection. 7/2/2104 Same as last inspection.

FIELD_STRUCT_DESC: 20-inch corrugated metal pipe through the levee, 19.8 feet below the crown. Two vertical pumps on pile structure on the waterward bank. Slide gate in concrete surge box on the waterward berm. Discharges into concrete distribution box on the landward side across the county road. Switch board on platform on bank. (ABO No. 9496 Womble). O&M manual 136, revision May 2011. FS Date: 04/16/2015

Waterside view: gate riser with slide gate

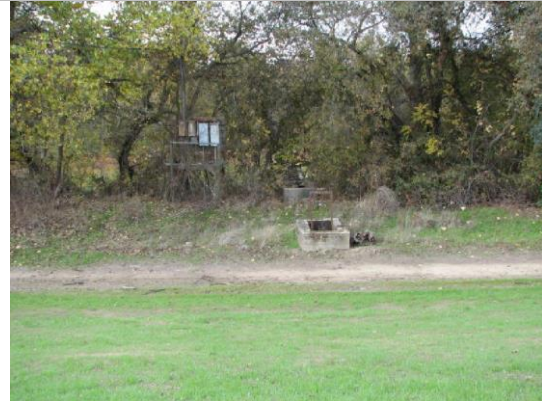
Photo 3 of 3 : UCIP_FA_2015_2654.jpg

Action/Comments					
Inspector Comments: FS_ID:44501 DS_ID:17370 EP_NO: 9496 FS_HLM: 20.041 Repair Type: Non-Urgent Crossing Status: Found UCIP Comments: 4/2/2015 Same as last inspection. Only one pump found on WS. An abandoned surge box found on WS and pipe is grouted with cement. Two 16-inch steel pipe found on pump station along with two electrical conduits. A concrete distribution box found on LS with 20-inch CMP. Appears abandoned crossing. 7/24/2013 Same as last inspection. 12/19/2013 Same as last inspection. 7/2/2104 Same as last inspection. FIELD_STRUCT_DESC: 20-inch corrugated metal pipe through the levee, 19.8 feet below the crown. Two vertical pumps on pile structure on the waterward bank. Slide gate in concrete surge box on the waterward berm. Discharges into concrete distribution box on the landward side across the county road. Switch board on platform on bank. (ABO No. 9496 Womble). O&M manual 136, revision May 2011. FS Date: 04/16/2015

Waterside view: overview

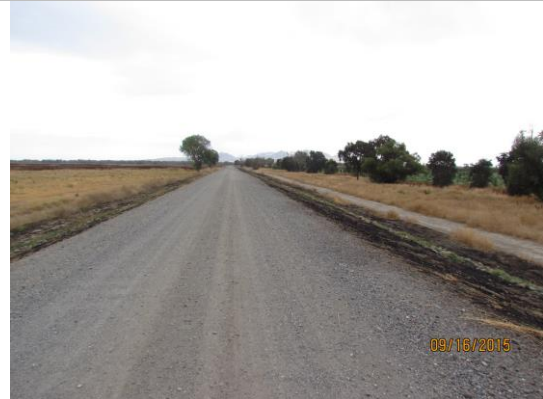
Photo 1 of 1 : FA_2015_ST0003_265_3_20151013_00003.jpg

LM Start	0.38	Rating **	A	Issue No.	3
LM End	0.38	Issue Type +	Ma	Location *	LS
Category	Earthen Levee			GPS Latitude/Longitude	
				Start	End
Item	Vegetation			39.231365 °	39.231365 °
				-121.988935 °	-121.988935 °
DWR ID	DWR_ST0003_02_f_2015_3				
Action/Comments					
Control annual grass and weeds on the levee slopes and easements. Inspector Comments: Sutter Yard burned and dragged both slopes.

View of the levee slope with no vegetation.

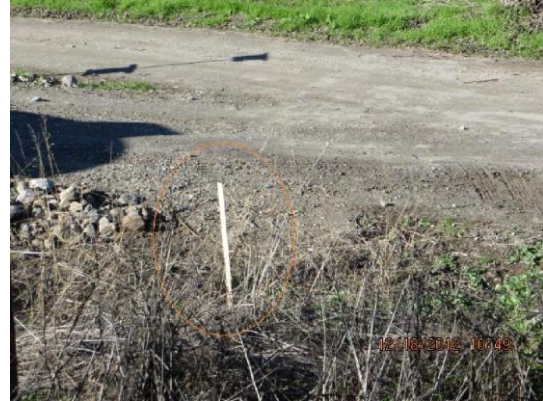
Photo 1 of 3 : UCIP_FA_2015_2729.jpg

LM Start	1.20	Rating **	M	Issue No.	4
LM End	1.20	Issue Type +	En	Location *	WS
Category	Supplemental			GPS Latitude/Longitude	
				Start	End
Item	DWR UCIP Field Study			39.229526 °	39.229526 °
				-121.975686 °	-121.975686 °
DWR ID					
Action/Comments					
Inspector Comments: FS_ID:44506					
DS_ID:17531					
EP_NO: 13534					
FS_HLM: 1.203					
Repair Type: Non-Urgent					
Crossing Status: Indicator Found

Landside view: gasline indicator

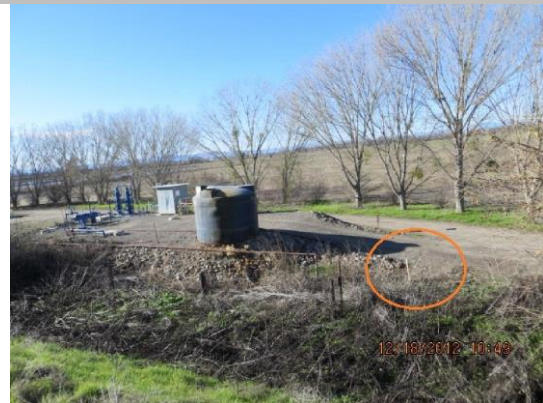
Photo 2 of 3 : UCIP_FA_2015_2730.jpg

Landside view: overview gasline indicator

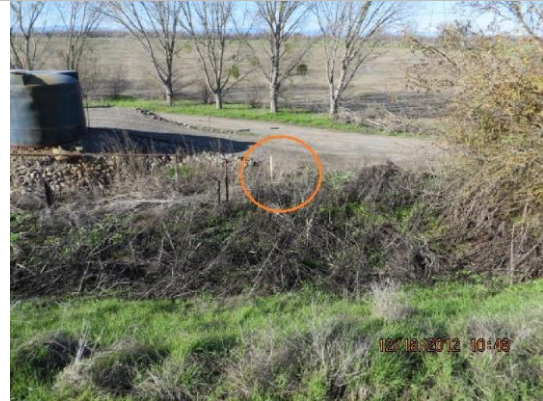
Photo 3 of 3 : UCIP_FA_2015_2731.jpg

LM Start	1.20	Rating **	M	Issue No.	4 (cont)	
LM End	1.20	Issue Type +	En	Location *	WS	
Category	Supplemental			GPS Latitude/Longitude		
				Start	End	
Item	DWR UCIP Field Study			39.229526 °	39.229526 °	
				-121.975686 °	-121.975686 °	
DWR ID						
Action/Comments						
Inspector Comments: FS_ID:44506						
DS_ID:17531						
EP_NO: 13534						
FS_HLM: 1.203						
Repair Type: Non-Urgent						
Crossing Status: Indicator Found

Landside view: overview gasline indicator

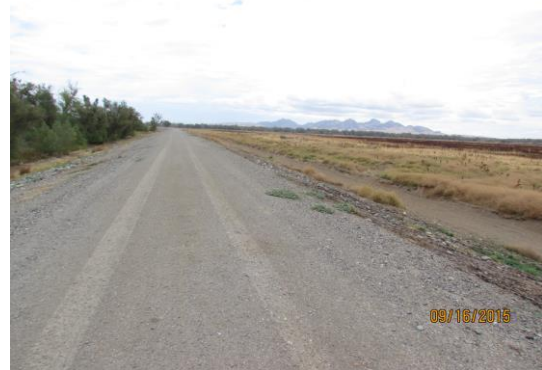
Photo 1 of 1 : FA_2015_ST0003_266_3_20151013_00005.jpg

LM Start	0.71	Rating **	A	Issue No.	3
LM End	0.71	Issue Type +	Ma	Location *	WS
Category	Earthen Levee			GPS Latitude/Longitude	
				Start	End
Item	Vegetation			39.237768 °	39.237768 °
				-121.981307 °	-121.981307 °
DWR ID	DWR_ST0003_03_f_2015_3				
Action/Comments					
Control annual grass and weeds on the levee slopes and easements. Inspector Comments: Sutter Yard burned and dragged both slopes.

View of the levee slopes with no vegetation.

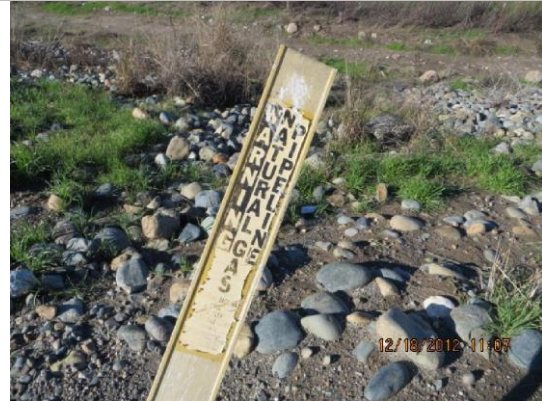
Photo 1 of 2 : UCIP_FA_2015_2732.jpg

Inspector Comments: FS_ID:44509
 DS_ID:17556
 EP_NO: 15821
 FS_HLM: 1.025
 Repair Type: Non-Urgent
 Crossing Status: Indicator Found
 UCIP Comments: 4/6/2015 Same as last inspection. May need to add additional gasoline markers. 7/22/2013 Same as last inspection. 12/19/2013 Same as last inspection. 7/7/2014 Same as last inspection.
 FIELD_STRUCT_DESC: One of three gaslines. 3- 4-inch natural gas pipeline under both levees and the Colusa Bypass with a distance of 12 inches between them and two inches on either side of the trench. One gasoline indicator found on LS.
 FS Date: 04/16/2015

Landside view: gasoline indicator close view

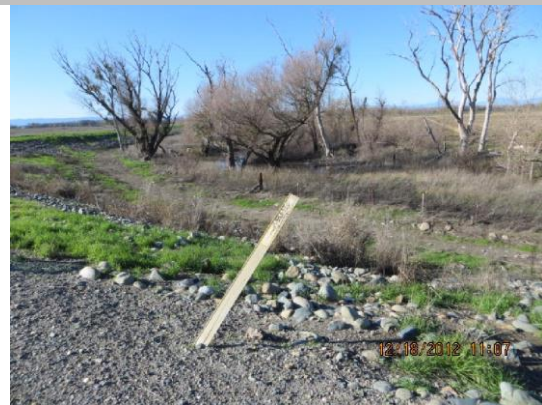
Photo 2 of 2 : UCIP_FA_2015_2733.jpg

Landside view: gasoline indicator

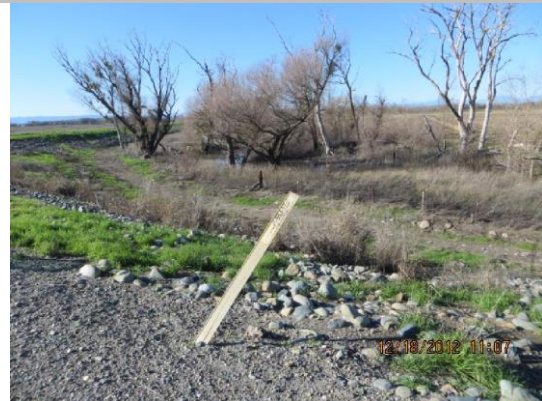
Photo 2 of 2 : UCIP_FA_2015_2737.jpg

LM Start	1.03	Rating **	M	Issue No.	12
LM End	1.03	Issue Type +	En	Location *	WS
Category	Supplemental			GPS Latitude/Longitude	
				Start	End
Item	DWR UCIP Field Study			39.239306 °	39.239306 °
				-121.975797 °	-121.975797 °
DWR ID					
Action/Comments					
Inspector Comments: FS_ID:44508					
DS_ID:17558					
EP_NO: 15821					
FS_HLM: 1.025					
Repair Type: Non-Urgent					
Crossing Status: Indicator Found

Landside view: gasoline indicator
